Family of Medium Tactical Vehicles (FMTV)

Team Newsletter

Vol 1 Issue 22

LMTV 2 1/2 Ton / MTV 5 Ton and Trailers

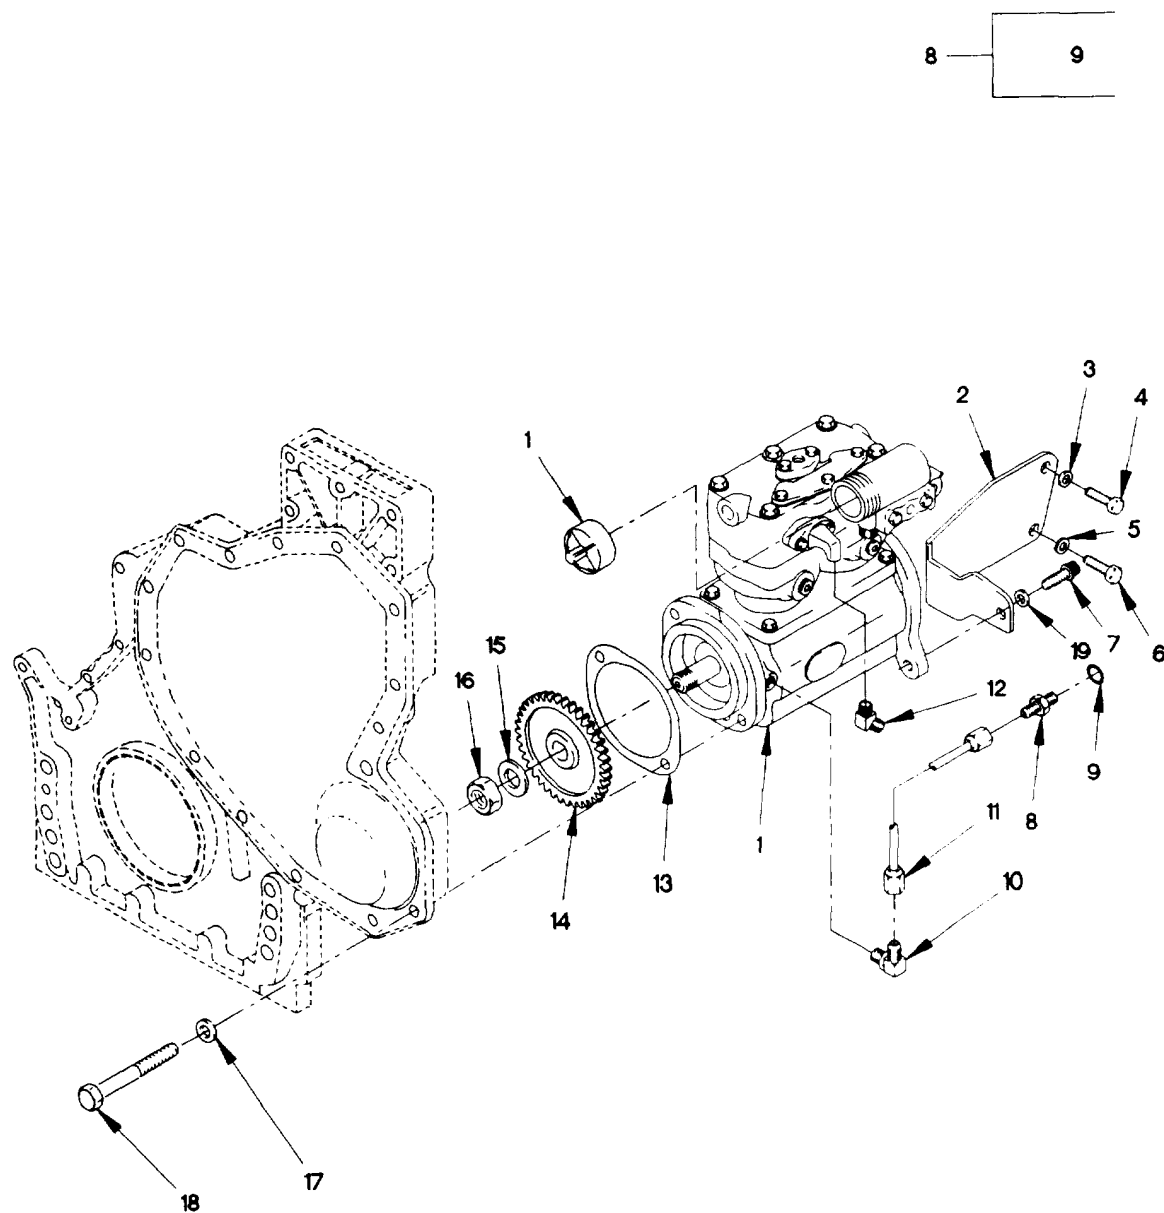
Figure 154. Air Compressor

There have been several reported failures of the front engine covers cracking on the FMTVs. This is due to the air compressor and/or alternator bracket bolts loosening up, causing the two components to vibrate, which in turn crack the front cover. The following is a procedure to prevent this. They are separated into two parts as follows:

3. Remove bolt (7) and washer (19) from mounting bracket (2). Discard washer.

4. Position bolt (7) and one new lockwasher (19) on mounting bracket (2). Tighten bolt (7) to 43-52 ft lbs (58-71 Nm).

5. Remove two lower bracket bolts (6) and washers (5) from mounting bracket (2). Discard washers.

6. Position two new washers (5) with bolts (6) in mounting bracket (2). Tighten bolts (6) to 43-52 ft lbs (58-71Nm).

7. Remove upper bracket bolt (4) and washer (3) from support bracket (2).

8. Position new lockwasher (3) and upper bracket bolt (4) in support bracket (2). Tighten bolt (4) to 43-52 ft lbs (58-71 Nm).
